This technical report describes the cleaning of M1 performed on 26.5.2021

EULER M1 CLEANING

Technical report

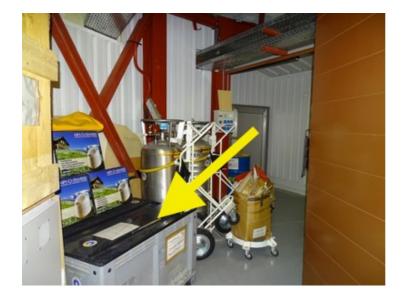
Fig. 1. Box where all the delicate (and not so delicate) items for mirror cleaning are located. Please take care of leaving things clean!! Here you will find the sponges, the special soap, the pipe and the compressed air pistol, the wooden block and the white foam to lower the telescope on, the mixer for the cleaning solution, the bucket and the small plastic pipe.

- Vacuum cleaner with a round brush
- Grey rubber tubes (located in the box labelled "Boudins d'isolation type SIKA") on the ground floor of the dome
- Two sponges which have been especially prepared: they are in two transparent plastic bags, located in the box shown in Fig. 1

- A large wooden stack (15cm width) to put on the raising table on the dome (in the same box shown in Fig. 1)
- One-two white rubber foam sheets to put on top of the wooden stack

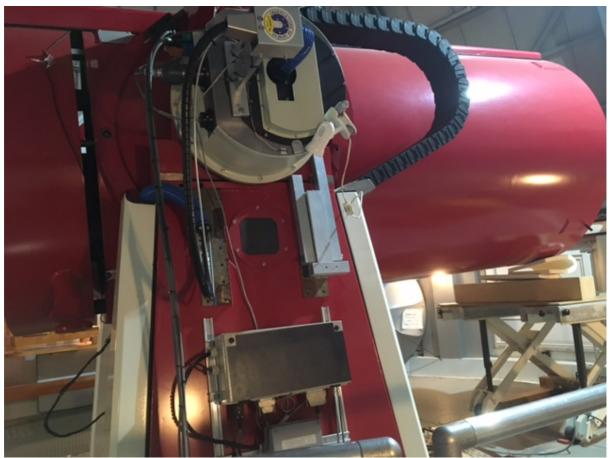
Fig. 3. The telescope is being lowered to the elevating table and the tube will go on top of the white foam visible above the wooden block. The height of the table can be adjusted with the handle located to its left.

The telescope was quite dirty: the minimum cleaning consisted of dusting off the top part, the floor below the telescope and the inside of the tube. To do so, the telescope was lowered on the elevating table located in the dome floor and placed on top of the wooden

stack, covered by a protective white foam sheet to avoid scratching the paint on the tube; the angle with the ground was \sim 5-10 degrees, see Fig. 3.

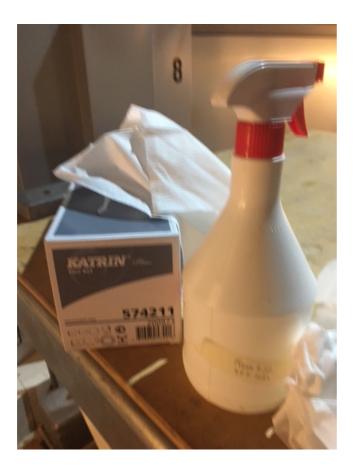
Fig. 4. Paper cloths and sprayer filled with drinkable water. They are located in the mechanical workshop

Now it is time to get in: donning a white protective overall, cap and shoe covers (actually it is much more practical to go in without shoes) and bringing in the paper cloths and the sprinkler shown in Fig. 4 filled with mineral water, one must clean inside the tube while moving in (clean first, THEN move in). It is advisable to do it with ease, the position is not the most comfortable and in the first leg the space is shared with the M2 cell, while in the last leg one must wrap oneself around M3 (and clean the baffle). It is important to be very careful there, as M3 is quite exposed.

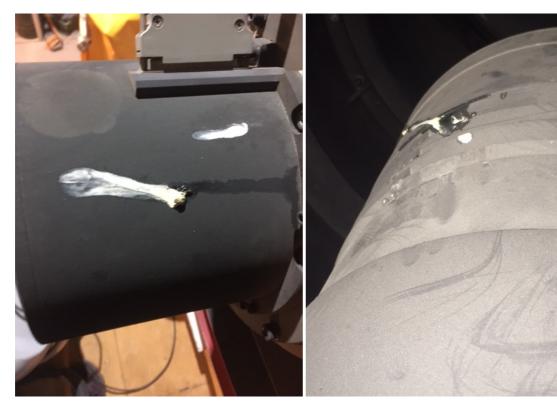
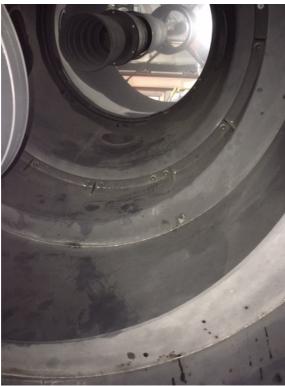
Fig. 5. From top left to top right and bottom left: M2 spider with bird droppings and dust and a view of the M1 and the inside of the telescope tube before the cleaning

Once the telescope is in position the emergency stop was pushed, and the preparation started. The vacuum cleaner was used to clean the external part of the tube and the top of the M2 cell and spiders. **Caution**: the brush is quite worn out, so it is useful only for first pass cleaning. After the first pass with the vacuum cleaner, a box of paper cloths located in the mechanical workshop and a sprayer filled with mineral water was used, see Fig. 4: water was sprayed on the cloth and I start to gently clean the dust off; for large surfaces and on safe location, water was sprayed directly on the parts, then cleaned immediately with the cloth. The tube and the M2 cell and spiders were very dirty, see Fig. 5: a double and in some cases a triple pass with vacuum cleaner and water+cloths was necessary. The floor below the telescope is sticky with oil, so it is was cleaned using the paper cloths and some water; using a vacuum cleaner will only dirty the cleaner without succeeding in cleaning.

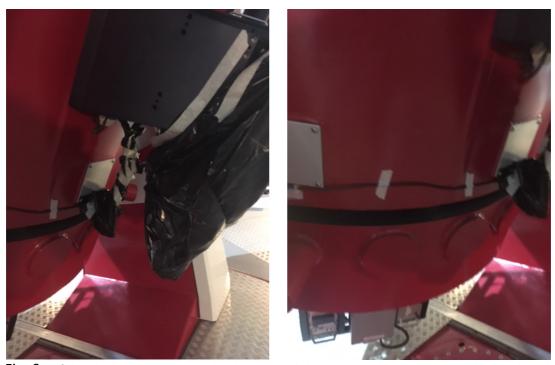
Fig. 6. Left hand panel: PISCO inside the clean rubbish bag; another bag has been used to insulate the dangling wires.

Right hand panel: fixing PISCO wires to the upper part of the telescope

Once the external cleaning is done, the floor and PISCO had to be protected from getting wet: a blue plastic sheet was placed below the telescope on the cleaned floor. Then the wires from PISCO were fixed on the upper body of the telescope tube and PISCO and the dangling wires were covered using a clean rubbish sack, see Fig. 6

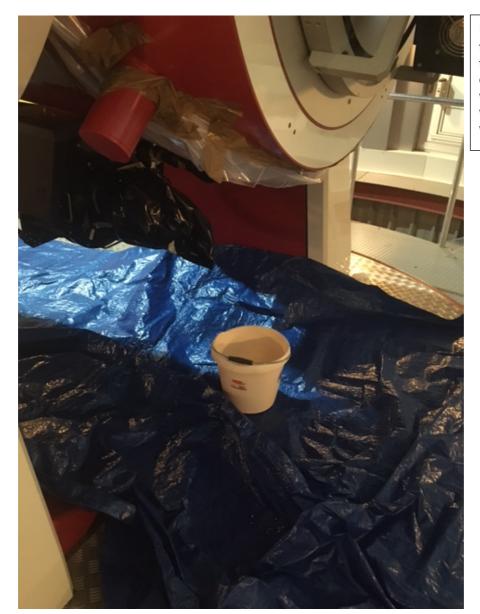
Fig. 7. Closing the lower half of the space between M1 cell and the tube in an attempt to control the direction of the water flow from M1 washing...and to avoid having water inside M1 cell.

After this, the water drip from M1 was directed into a defined place: using a white plastic sheet, and a water resistant tape (alias packaging tape), the lower half of the space between the tube and M1 cell was closed, see Fig. 7. An hole in the plastic sheet at the minimum height was practiced and the pipe shown in Fig. 8 was taped in; it is important to be sure that the outlet of the pipe is level with the plastic sheet, otherwise the water will not get out (check from the inside of the tube). A clean bucket was placed below to collect the water and soap from the pipe.

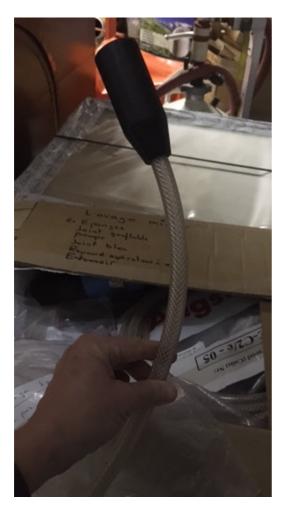
Fig. 8. The small pipe used to collect at the bottom of M1 $\,$

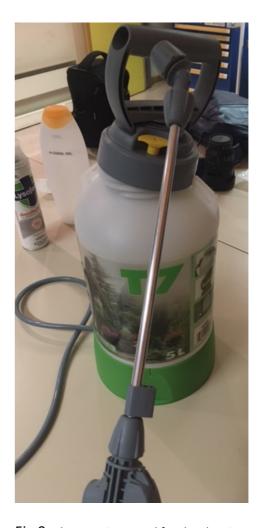
Fig 9. The container used for the cleaning mixture

Following this, the cleaning solution was prepared by mixing ~3-4l of warm demineralized water and about two small shots of "savon d'orvu", which was also warmed up in advance; the mixture was checked for the right "feeling", i.e. it must glide between the fingers, and placed in the garden sprayer of Fig. 9. The container will be operated by someone outside the tube (Gregorio) and the pipe will be passed in the upper space between the M1 cell and the telescope tube.

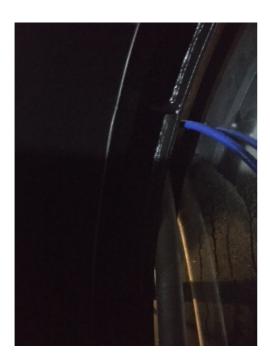
Fig. 10. Here is visible the compressed air pipe (blue one) inside the tube and (barely visible) the grey tube used around M1. Below it, there is the pipe and sprinkler for the cleaning solution

Finally Gregorio was asked to pass through the upper space between M1 and the tube the cleaning hose and the air compressed pistol, see Fig. 10. Handled with care to avoid touching M1.
